Manhole Inspection Summary

Manhole # S41I__035MH

Location Address: **front of 324 exerter st**

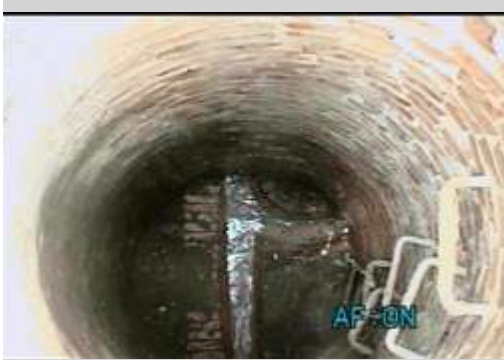
Defect 2

Infiltration: ☐ None ☐ Joint ☐ Cracks ☐ Mortar ☐ Roots ☒ **Wall**

Condition: ☐ Sound ☐ Cracked ☐ Root Intrusion ☐ Deteriorated ☐ Leaks ☒ **Debris**

bench debris, barrel wall infiltration

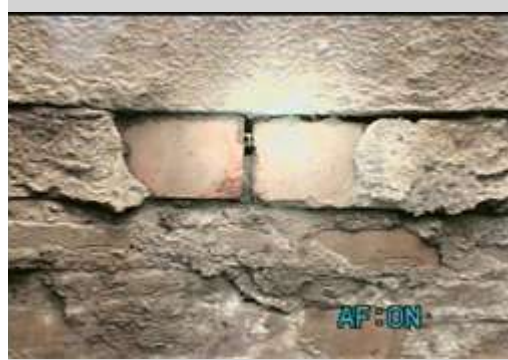
Defect 1

Condition: ☐ Sound ☐ Cracked ☐ Root Intrusion ☐ Loose Brick ☒ **Deteriorated**

deteriorated, adj

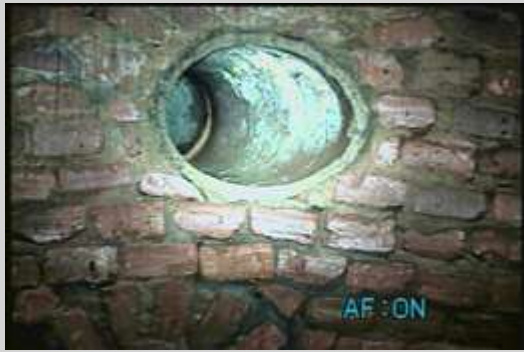
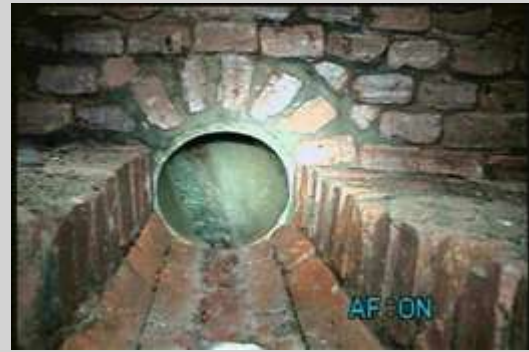
6 O'Clock Inflow

Drop: **Inside** **Direct**

Drop Condition: **Open**
